UROLIFT[®]
BPH Relief. In Sight.[™]

**Before and After
Photos of the
UroLift[®] Procedure**

UroLift® System Procedure

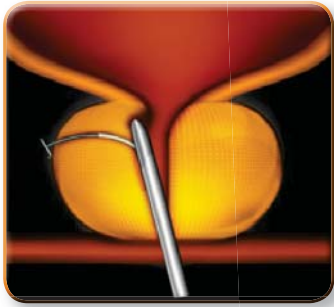
Step 1

The UroLift® Delivery Device is placed through the obstructed urethra to access the enlarged prostate.

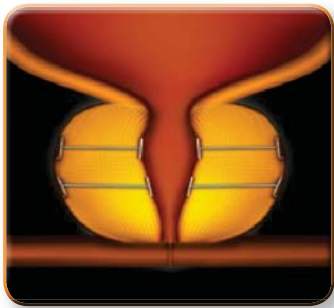
Step 3

The UroLift Delivery Device is removed, leaving an open urethra designed to provide symptom relief.
